# Manhole Inspection Summary

Manhole # S25A\_\_001MH

Insp Date: **8/20/07 8:57 AM**

**Location** Address: **1206 EDMONDSON AVE**

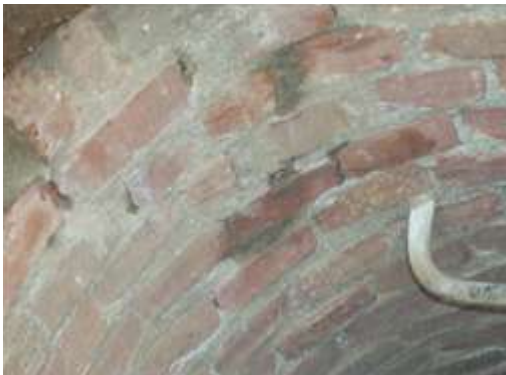
Defect 3

Condition: ☐ Sound ☒ **Cracked** ☐ Root Intrusion ☐ Loose Brick ☐ Deteriorated

Infiltration: ☐ None ☐ Joint ☐ Cracks ☐ Mortar ☐ Roots ☒ **Wall**

CRACKED AND INFILTRATION  
CORBEL

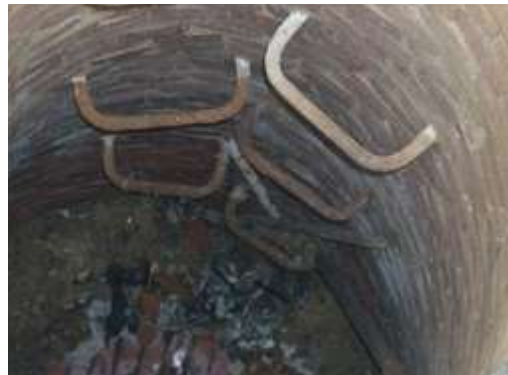
Defect 2

Count: **6** Missing: **0** ☒ **Corroded**

CORRODED STEPS

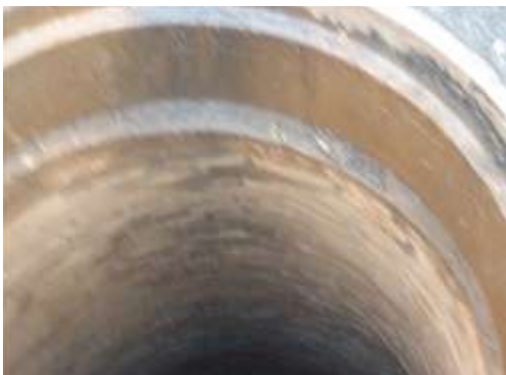
Defect 1

Offset: **1** (in.)

FRAME OFFSET

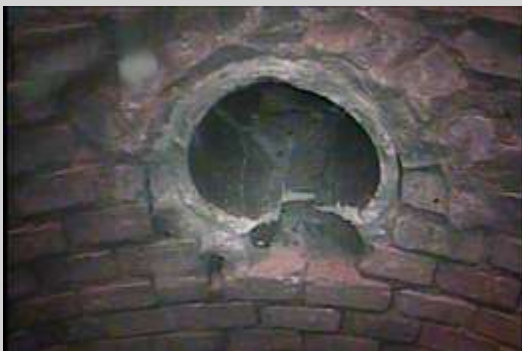
3 O'Clock Inflow

Pipe Height: **8.4** (in.) Rod and Bar (Angled)  
Pipe Material: **Clay** ☐ Pipe Lined  
Invert Depth: **8.04** (ft.) Flow Characteristics: **Slow**  
Deposits: ☒ None ☐ Mud ☐ Sludge ☐ Debris ☐ Grease  
Silt Depth: (in.) Deposits Extent:  
Infiltration: **None** Pipe Seal Cond: **Broken**

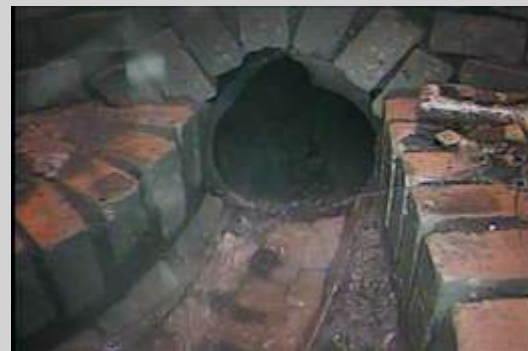
Drop In @ 3 O'Clock

Drop: **Outside** Rod and Bar  
Angled: **Yes** Reading: **9.64** (ft.)  
Inv Depth: **10.64** (ft.)  
Drop Condition: **Partly Clogged**
